STATE OF TENNESSEE
DEPARTMENT OF ENVIRONMENT AND CONSERVATION
DIVISION OF WATER RESOURCES

Re: Notice of Violation (NOV)
 Compliance Evaluation Inspection
 Memphis-TE Maxson STP
 NPDES Permit No. TN0020729
 Shelby County

ICIS NPDES Facilities Inspection Report

Compliance Inspection for Individual NPDES Permit

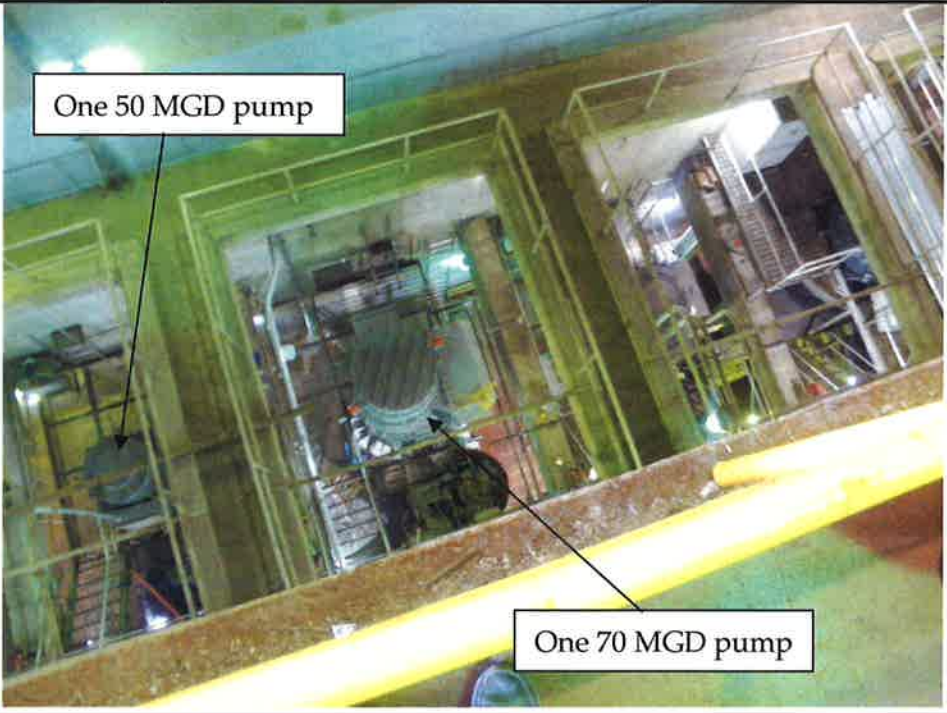
The Memphis-TE Maxson STP has four influent pumps (two pumps have 50 MGD capacity and two pumps have 70 MGD capacity) in the pump building located at the head of the plant (photo 1). One 50 MGD pump and one 70 MGD pump were in service at the time of the inspection.

Description View of the influent pumps in the pump building at the head of the plant.			
Photo No. <div style="text-align: center; border: 1px solid black; width: 40px; margin: 0 auto;">2</div>	Date <div style="text-align: center; border: 1px solid black; width: 100px; margin: 0 auto;">10-19-2016</div>

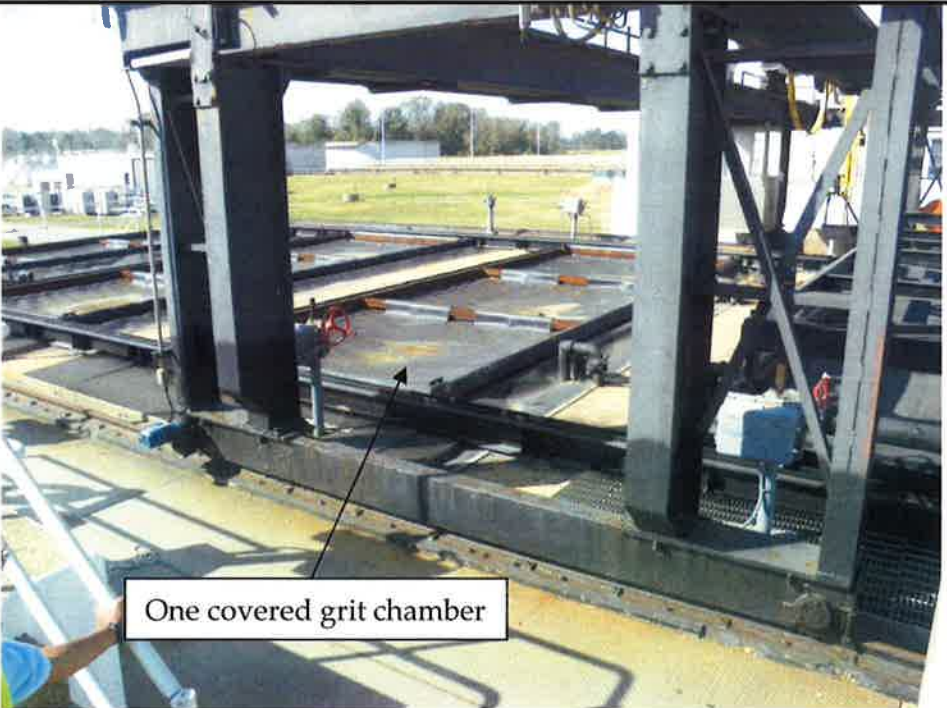
The STP consists of four covered grit chambers (photo 2), each with a bar screen, three fine bar screens (photo 3), four primary clarifiers (photo 4), six activated bio-filter (ABF) towers (photo 5), fourteen aeration basins (photo 6) and ten secondary clarifiers (photo 7). Three primary clarifiers and five ABF towers were in operation at the time of the inspection. One primary clarifier was being serviced, four aeration basins and three secondary clarifiers were out of service due to low flow period.

Description View of the covered grit chambers.

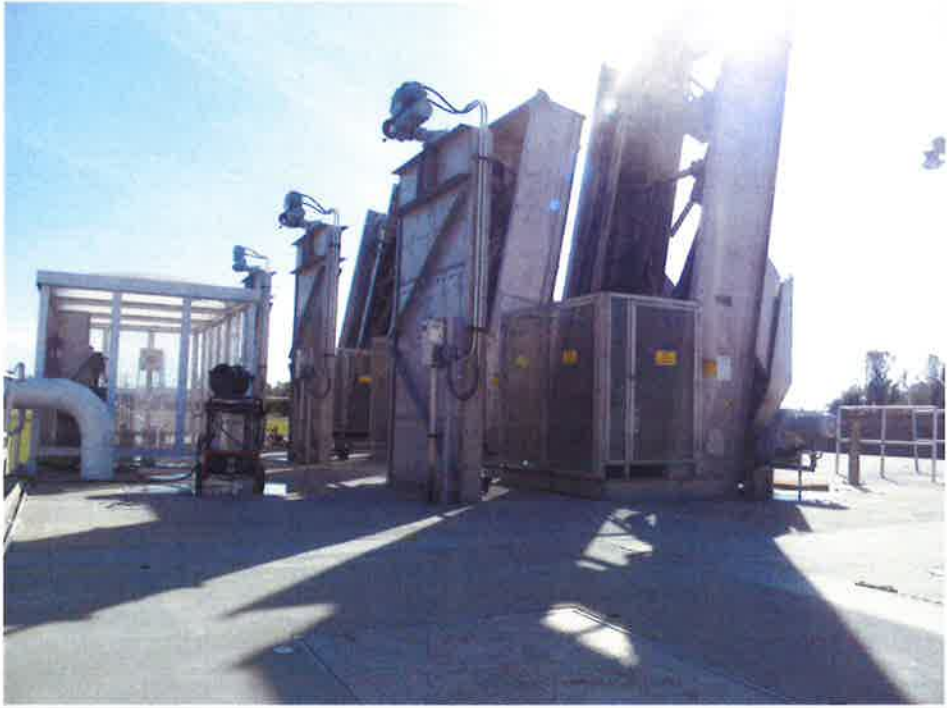
Facility Name: Memphis-TE Maxson STP		Site Location: Memphis, Shelby County	Tracking No.: TN0020729
Photo No. 3	Date 10-19-2016

Description View of the fine bar screens.

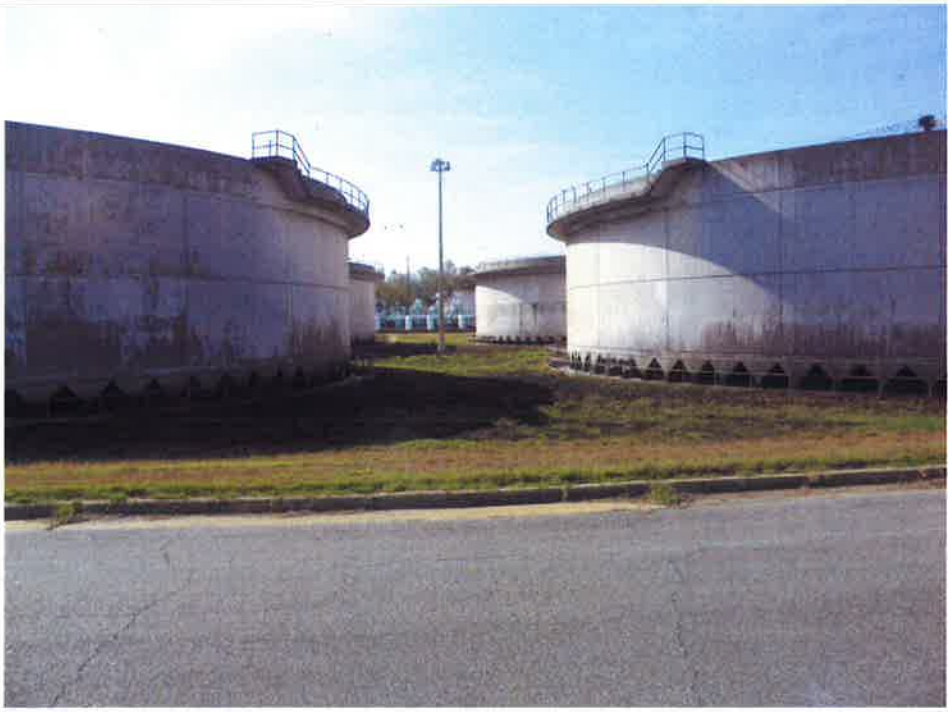
Photo No. <div style="text-align: center;">5</div>	Date <div style="text-align: center;">10-19-2016</div>

Description View of the bio-filter towers.

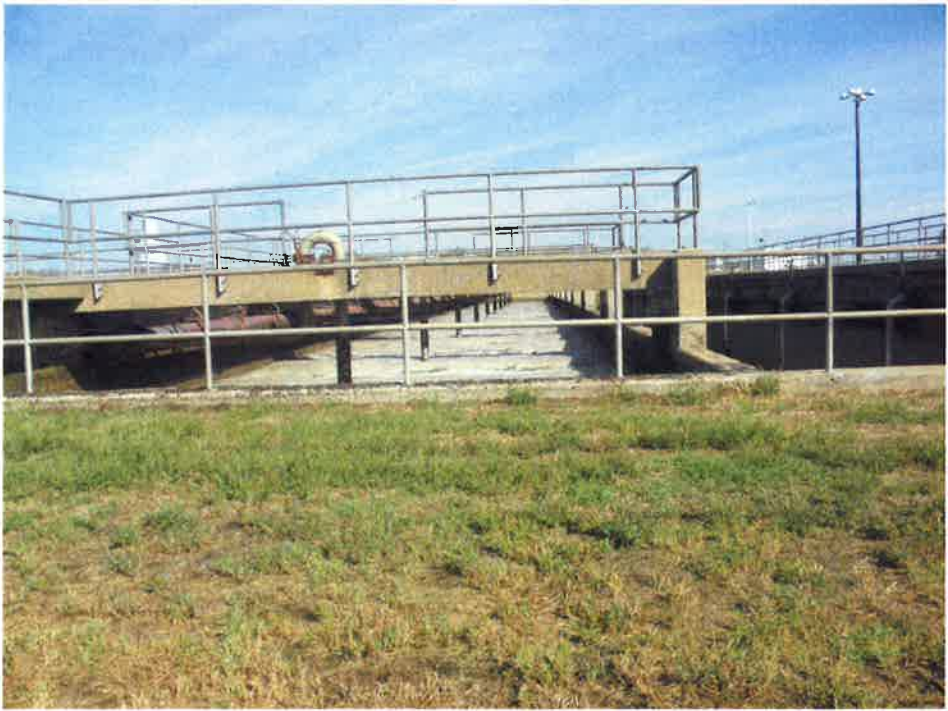
Photo No. <div style="text-align: center;">6</div>	Date <div style="text-align: center;">10-19-2016</div>

Description View of one aeration basin.

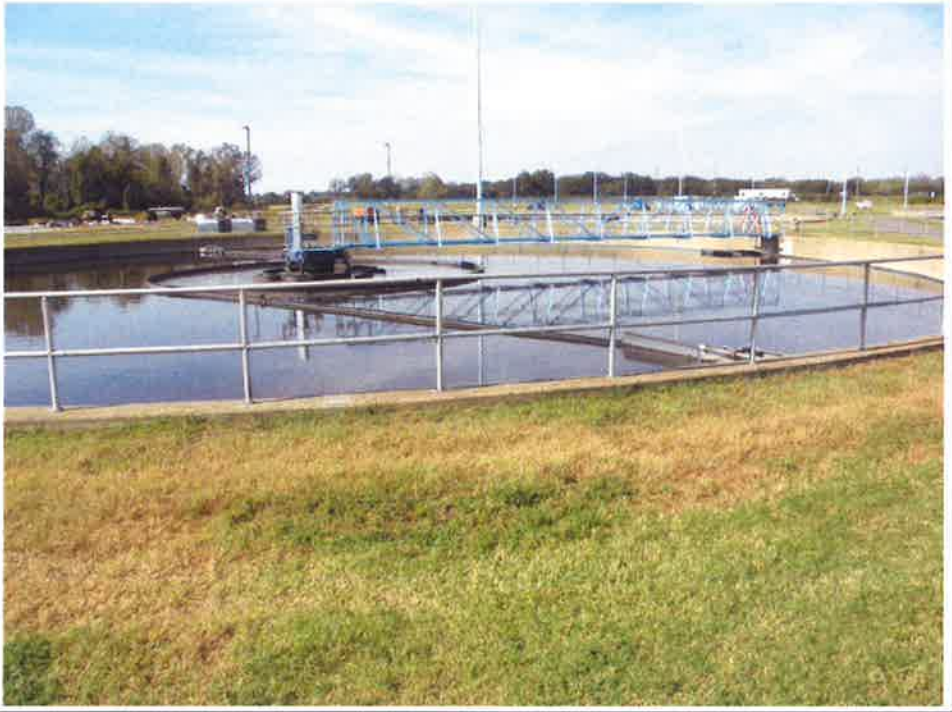
Facility Name: Memphis-TE Maxson STP		Site Location: Memphis, Shelby County	Tracking No.: TN0020729
Photo No. 7	Date 10-19-2016

Description View of a secondary clarifier.			
Photo No. 8	Date 10-19-2016

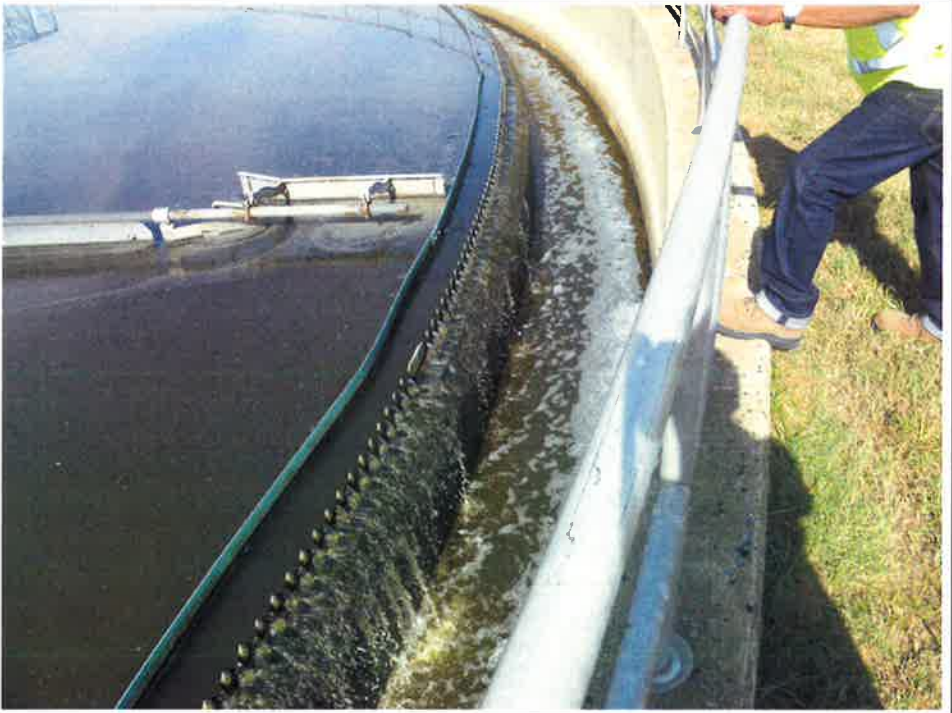
The overflow weirs from the clarifiers appeared clean (photo 8).

Description Close-up view of an overflow weir from a secondary clarifier.

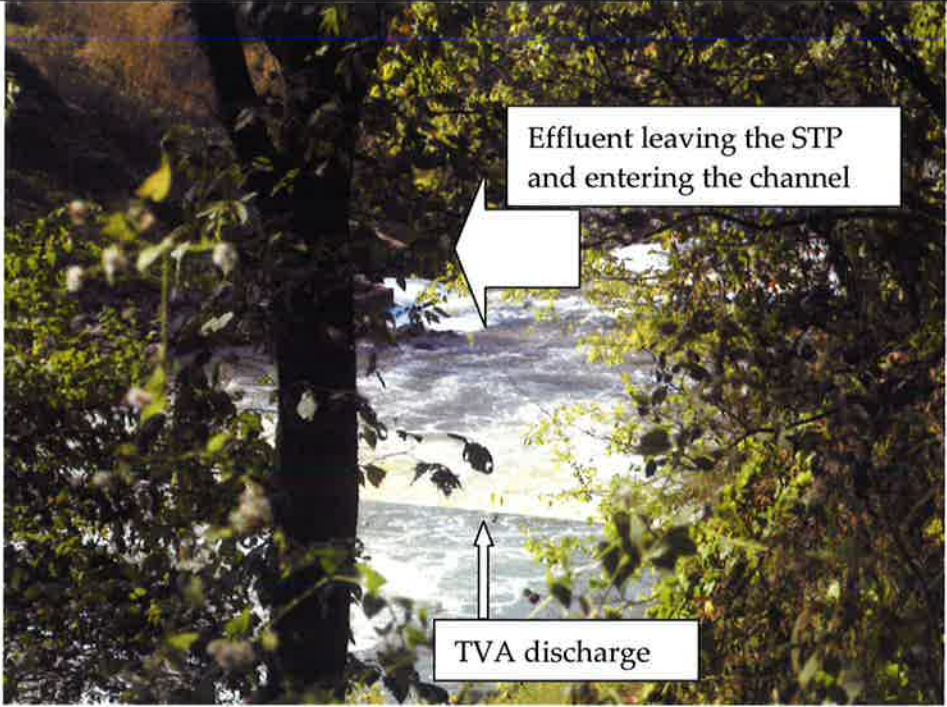
Facility Name: Memphis-TE Maxson STP		Site Location: Memphis, Shelby County	Tracking No.: TN0020729
Photo No. 9	Date 10-19-2016

From the secondary clarifiers, the treated wastewater is discharged through a channel that also conveys discharge from the TVA Allen Steam Plant before entering the Mississippi River (photo 9).

<div style="position: absolute; top: 220px; left: 650px; border: 1px solid black; padding: 5px; background: white;"> Effluent leaving the STP and entering the channel </div> <div style="position: absolute; top: 460px; left: 610px; border: 1px solid black; padding: 5px; background: white;"> TVA discharge </div>	
Description View of the effluent entering a channel that also conveys discharge from the TVA Allen Steam Plant before entering the Mississippi River.			
Photo No. 10	Date 10-19-2016

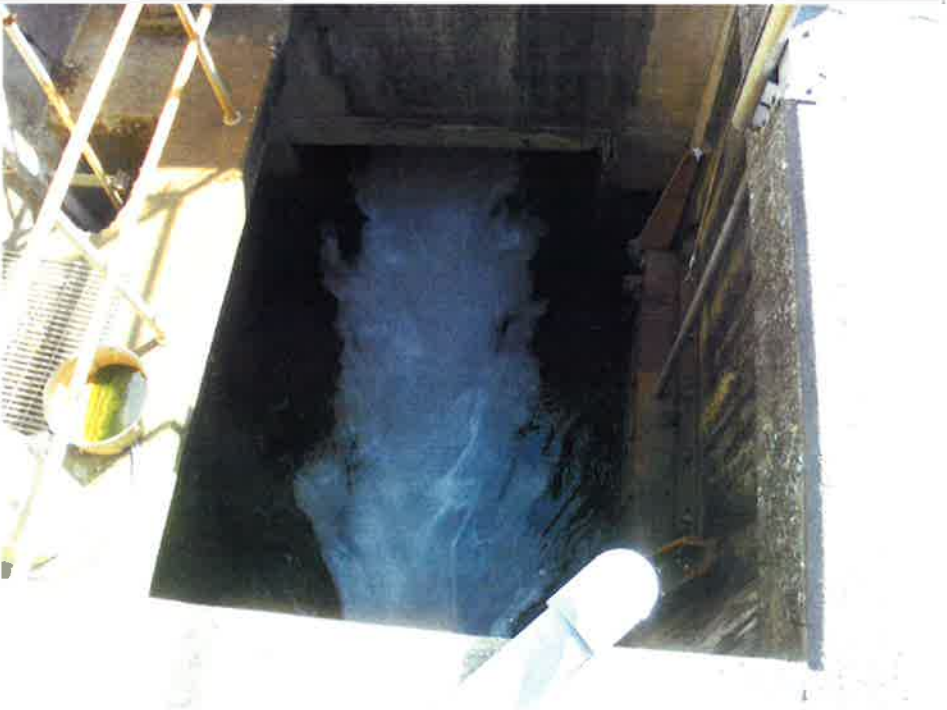
The effluent was slightly tan in color and foamy in the concrete structure before leaving the plant (photo 10). The effluent at the outfall feeds into a channel which then travels approximately half a mile before entering the Mississippi River (photo 11).

Description View of the effluent in the concrete structure before leaving the plant.

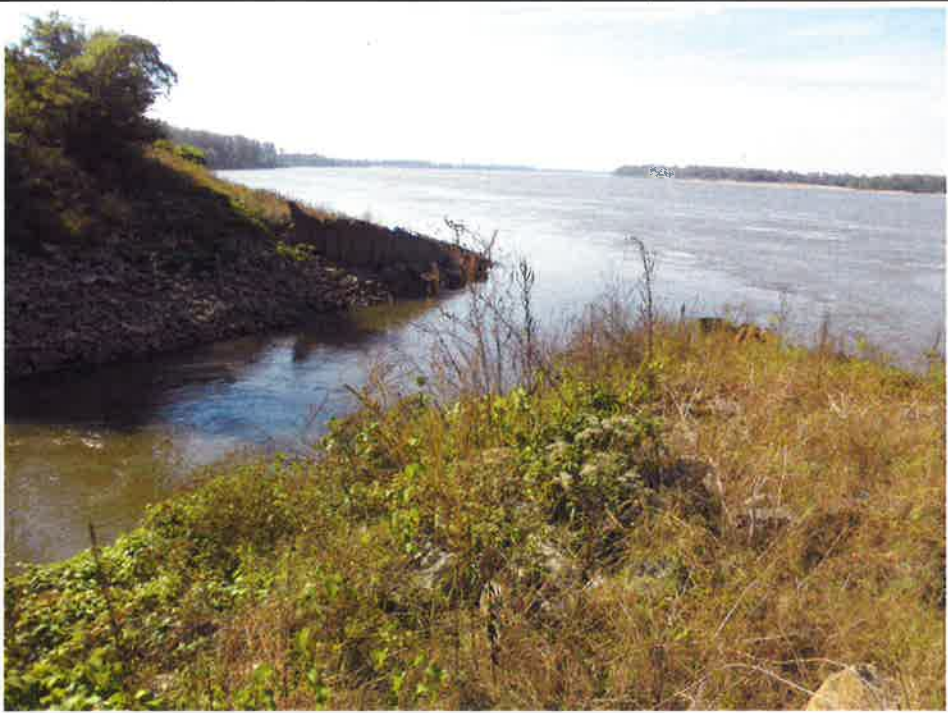
Photo No. <div style="text-align: center;">11</div>	Date <div style="text-align: center;">10-19-2016</div>	<div style="border-bottom: 1px solid black; padding-bottom: 5px;"> Description View of the channel that conveys the STP effluent and the TVA discharge before entering the Mississippi River. </div> <div style="padding-top: 10px;">

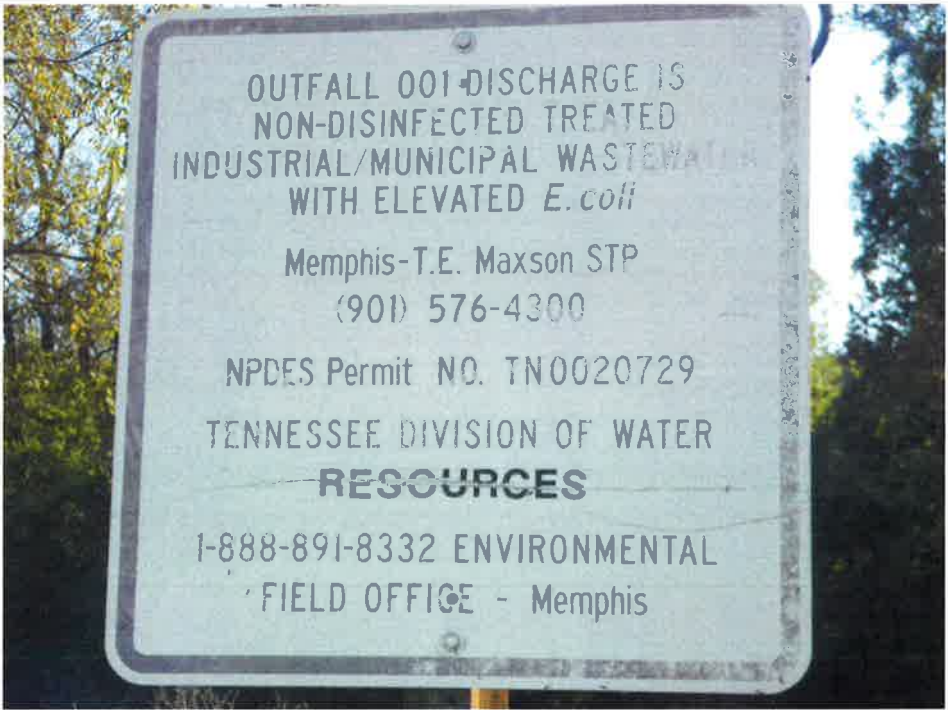
The sign was in place at the point of discharge at the Mississippi River (photo 12) and the information on the sign was correct.

Photo No. <div style="text-align: center;">12</div>	Date <div style="text-align: center;">10-19-2016</div>	<div style="border-bottom: 1px solid black; padding-bottom: 5px;"> Description View of the sign at the outfall. All the information on the sign was correct. </div> <div style="padding-top: 10px;">

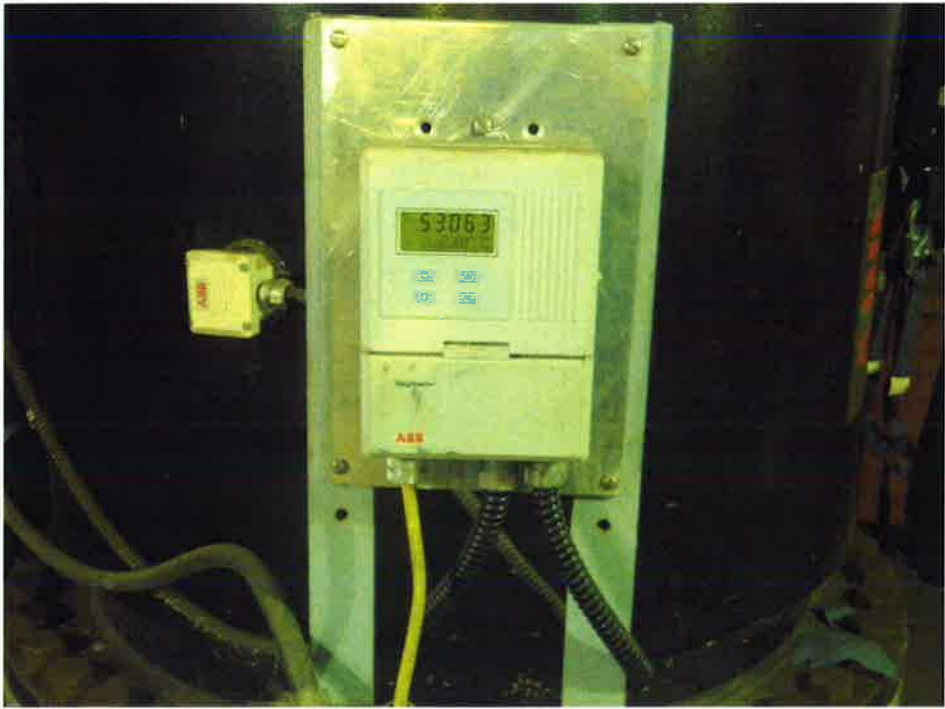
A flow meter is installed in the pump building at the head of the plant (photo 13) to measure the influent. The device appeared to be operating properly during the time of the inspection. According to Mr. Bower the flow meter is calibrated by the manufacturer annually. Records indicate the last calibration was conducted on July 6, 2016. A calibration certification was available for review. Although the permit requires measurement of effluent flow, the influent flow is currently recorded as the effluent flow since the facility does not have an effluent flow meter.

13	10-19-2016		
Description View of the influent digital flow meter.
